CONNECTICUT RIVER BASIN  
WHITINGHAM

LAKE SADAWGA  
VT00012

PHASE I INSPECTION REPORT  
NATIONAL DAM INSPECTION PROGRAM

AUGUST 1978

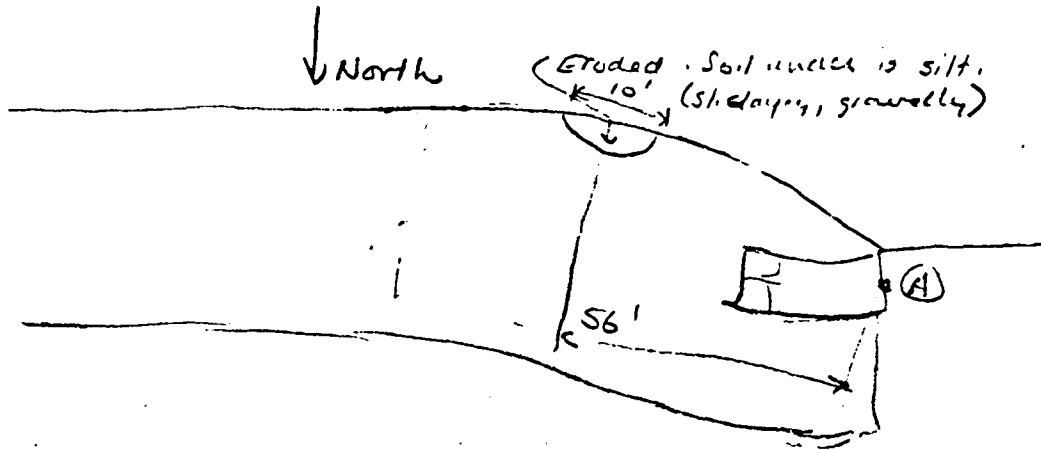
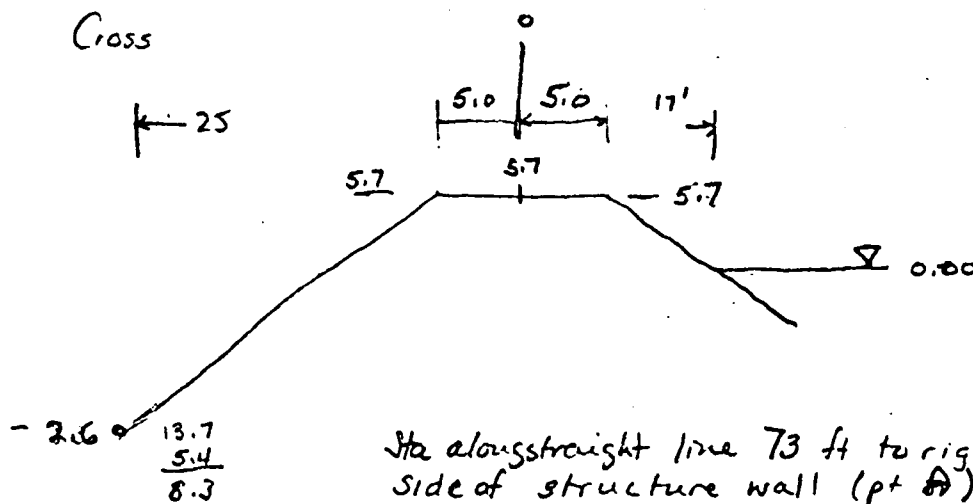
Erosion upstream to right of structure as shown.

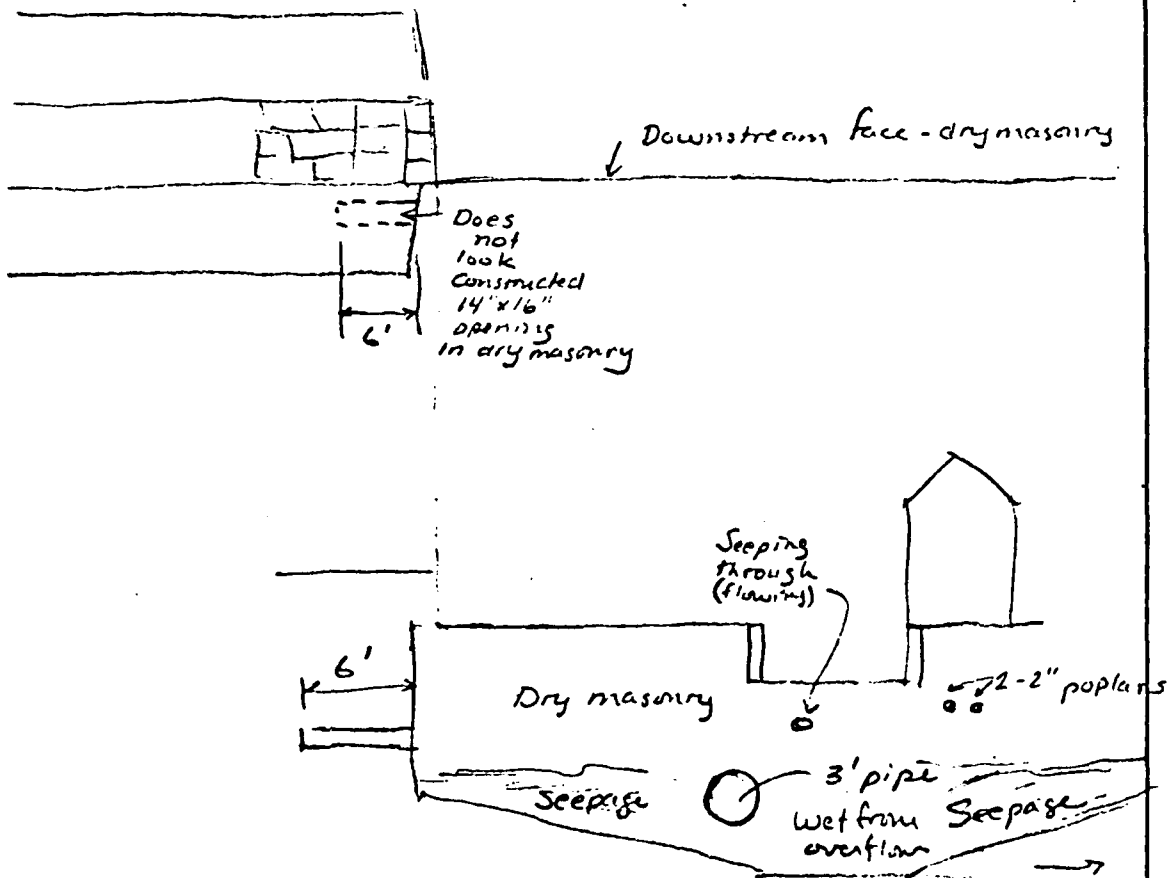
Hole in rt. abutment.

Structure is founded on quartzite or schist bedrock dipping 14° N striking N75E

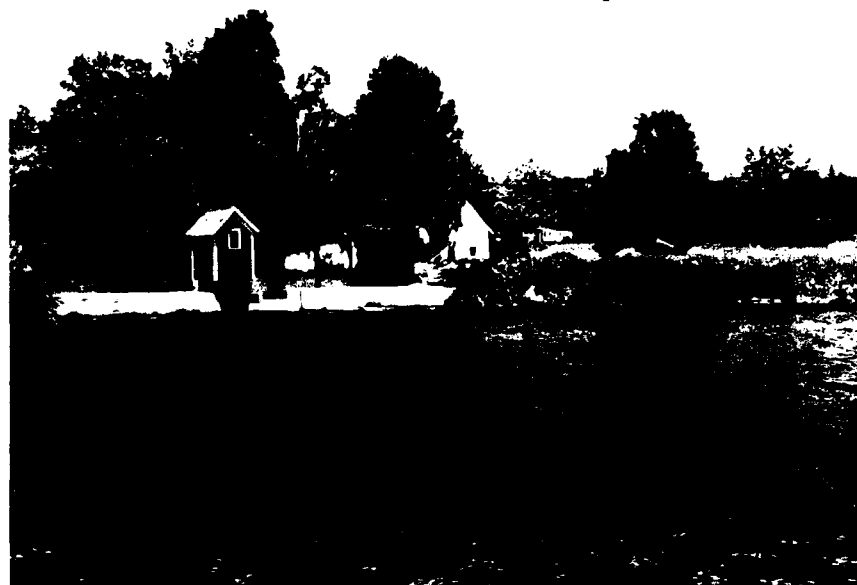
#1 UPSTREAM OF LAKE SADAWGA DAM, LOOKING AT SPILLWAY SECTION

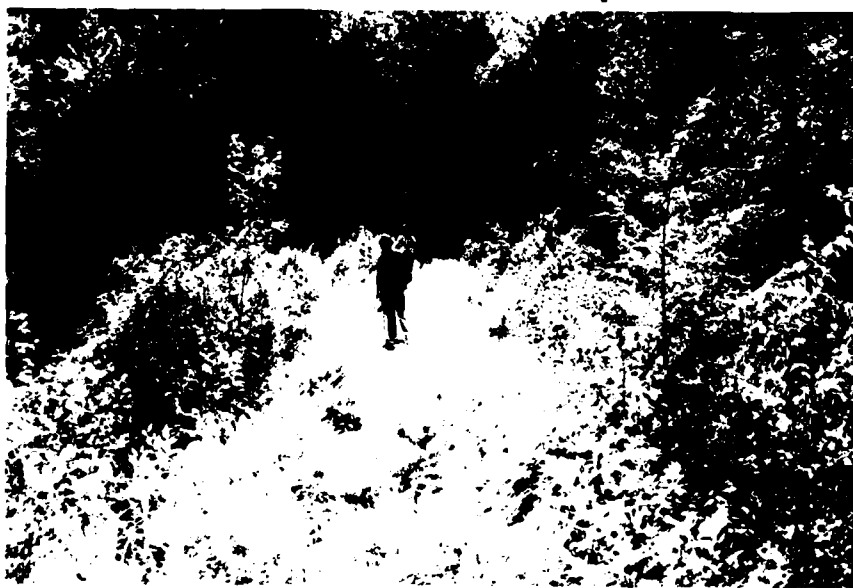
The West Dike has a crest width of only a few feet. In the records it appears that for a "rare storm" (1640 cfs inflow, 11% of PMF) the freeboard will drop to only 2 feet. Under these conditions the West Dike will be in substantial danger of eroding through due to only minor wave action, because the crest is narrow and the slopes are steep.

#4 WEST DIKE

1. Redesign and rebuild the West Dike to make it equivalent to the dam.
2. Monitor settlement of the cracked portion of the control section and redesign this structure as necessary.

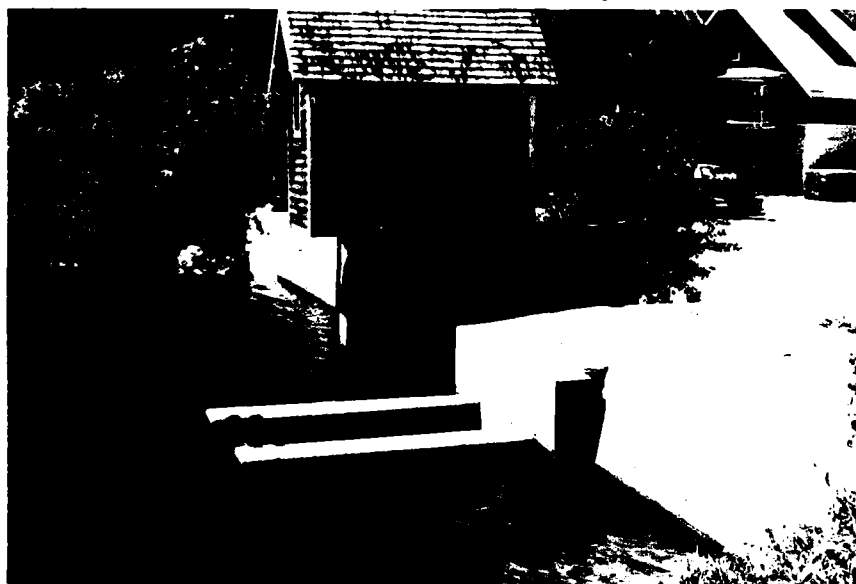
#5 SPILLWAY, DROP-INLET AND GATEHOUSE

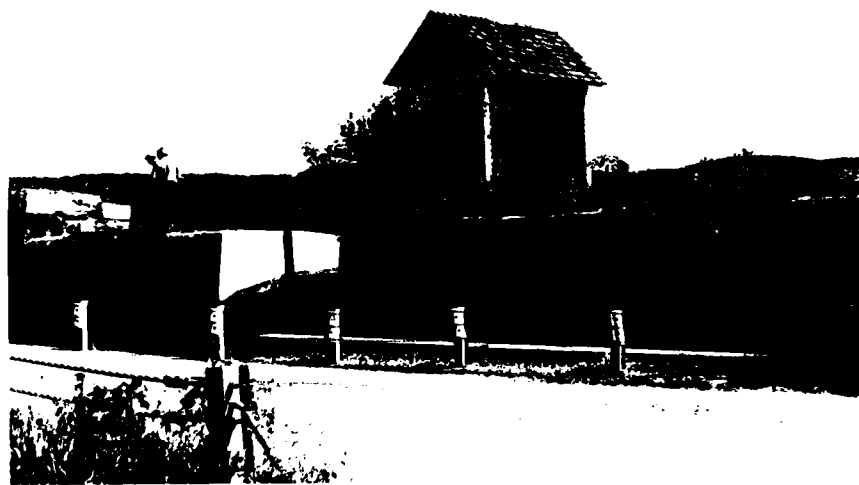
#6 SPILLWAY, GATEHOUSE FROM DOWNSTREAM

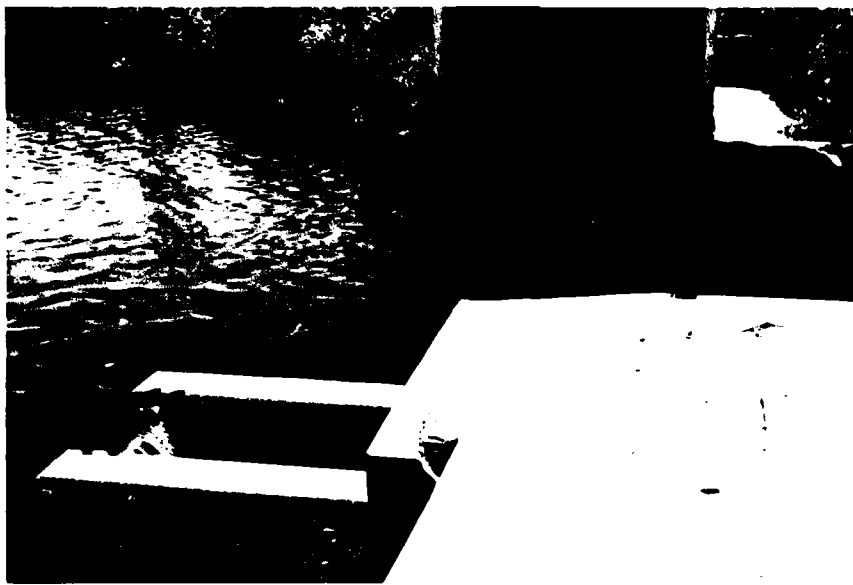
#7 DROP INLET, ALSO NOTE CRACKED CONCRETE

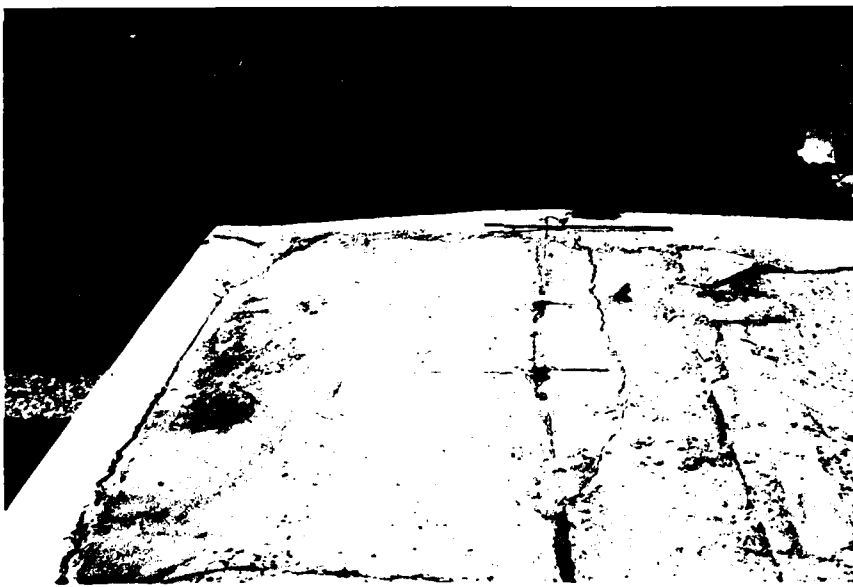
A portion of the concrete cap is in fair condition, since it is severely cracked and shows signs of settlement. It should be monitored to determine whether settlement is occurring. It is also recommended that the condition of the penstock where it penetrates the wall be determined.

The concrete cap shows evidence of deterioration in the form of light scaling and medium surface cracks. A portion of the cap just to the right of the control section (see Photo 8 in Appendix C) approximately 4 feet x 8 feet in plan appears to have settled and cracked. This portion of the cap is located directly over the old 3.9-foot diameter penstock where it penetrates the masonry wall.

#8 VIEW OF CRACKED CONCRETE ON SPILLWAY
